NRCS Actions: NRCS staff have been in the field since Sunday morning, evaluating damage across the entire area affected by the June 7 - 8 storms. We're working closely with local partners, County staff, and the State Dam Safety Engineers, and taking precautions to ensure inspections are completed safely.

High Risk Structures: The Wisconsin State Conservationist has received approval for EWP exigency funds to provide emergency repairs for the following three dams in Vernon County, to prevent further damage or failure -

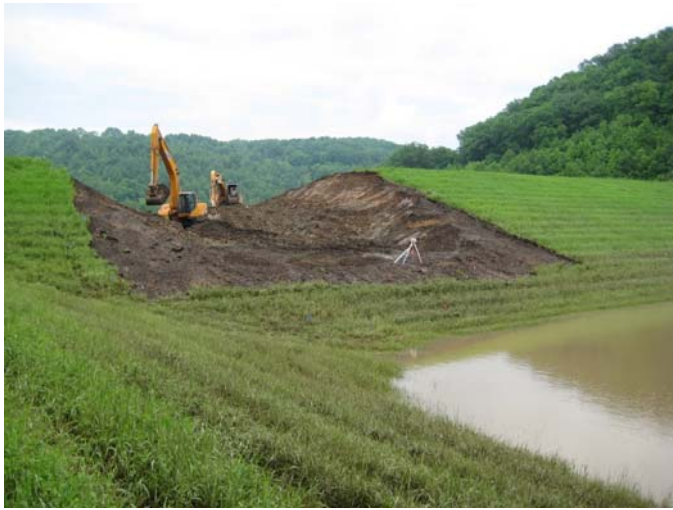
Primmer breach – 11 am June 12

West Fork Kickapoo 17 (Primmer) - The water level on June 9 was 2 feet over the top riser. Seepage and slumping from the right abutment has moved upstream to the base of the dam. A state highway, 2 homes, and a bridge are at risk downstream from the dam. An emergency controlled partial breach of the dam is in progress (Thu, June 12). Construction activities are 80% complete, and will reduce the potential damage from future storm events.

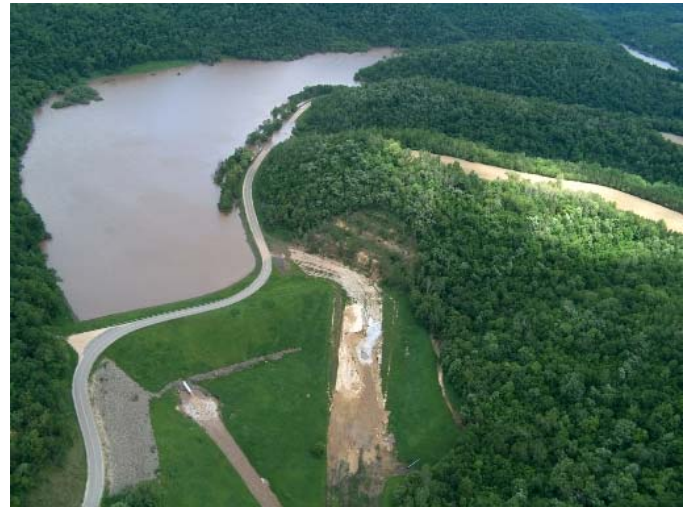
Runge Hollow – June 11

Runge Hollow (Bad Axe 12) - Flow was up to, but not over the control section of the auxiliary spillway. Water is coming through the left abutment and into the previously completed temporary chute fix. The structure is at risk of further damage with another significant storm event. Evaluation continues.
